Contract #: 04-0120F4Cty: SF/ALA Rte: 80 PM: 13.2/13.9File #: 69.28**WELDING INSPECTION REPORT****Resident Engineer:**Pursell, Gary**Address:** 333 Burma Road**City:** Oakland, CA 94607**Report No:** WIR-014375**Date Inspected:** 09-May-2010**Project Name:** SAS Superstructure**OSM Arrival Time:** 700**Prime Contractor:** American Bridge/Fluor Enterprises, a JV**OSM Departure Time:** 1900**Contractor:** Zhenhua Port Machinery Company, Ltd (ZPMC), Changxing Island **Location:** Shanghai, China**CWI Name:** Wu Chi Chen and Li Yand**CWI Present:** Yes No**Inspected CWI report:** Yes No N/A**Rod Oven in Use:** Yes No N/A**Electrode to specification:** Yes No N/A**Weld Procedures Followed:** Yes No N/A**Qualified Welders:** Yes No N/A**Verified Joint Fit-up:** Yes No N/A**Approved Drawings:** Yes No N/A**Approved WPS:** Yes No N/A**Delayed / Cancelled:** Yes No N/A**Bridge No:** 34-0006**Component:** OBG Trial Assembly**Summary of Items Observed:**

Orthotropic Box Girder (OBG) Trial Assembly Areas

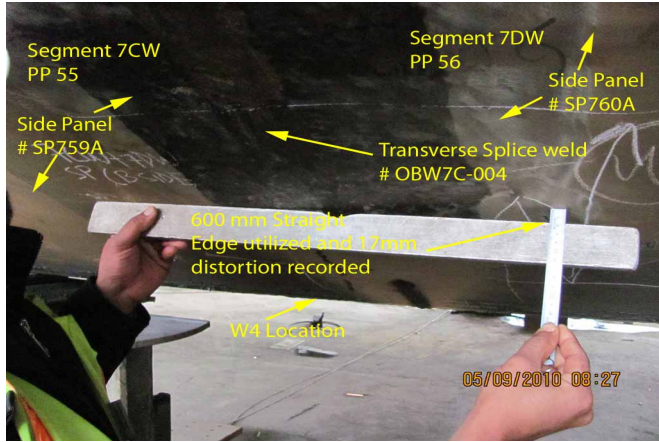
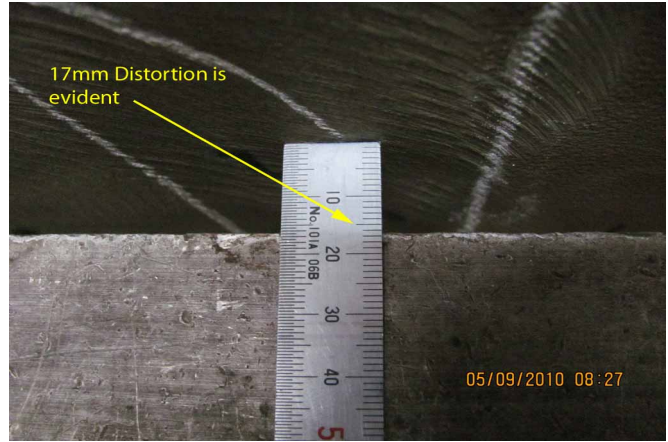
This Quality Assurance (QA) Inspector wrote an Incident Report for flatness of Transverse Splice Segment weld at Side Panel Cross Beam side for Segment 7CW to Segment 7DW between Panel Point (PP) 55 and PP 56 for more comprehensive details please refer the Incident Report # 04-0120F4_TL-15_B278_05-09-2010_Side Panel Flatness at Transverse Splice Weld_7CW to 7DW between PP 55 to PP 56 Dated May 09, 2010. Please refer the pictures for more comprehensive details.
